October 16, 2017

William Federiconi
194 Forbes St.
Amsterdam, NY 12010

The following structural report details the findings and recommendations for the structural site inspection, conducted on September 20th, 2017, of your home located at the above address. The inspection is intended to provide you information regarding this structure's viability to continue serving as a rental unit, in lieu of the partial collapse of a retaining wall to the rear of the home. As discussed, you would like to continue to rent the home, but cannot do so until the home is deemed structurally safe for future tenants.

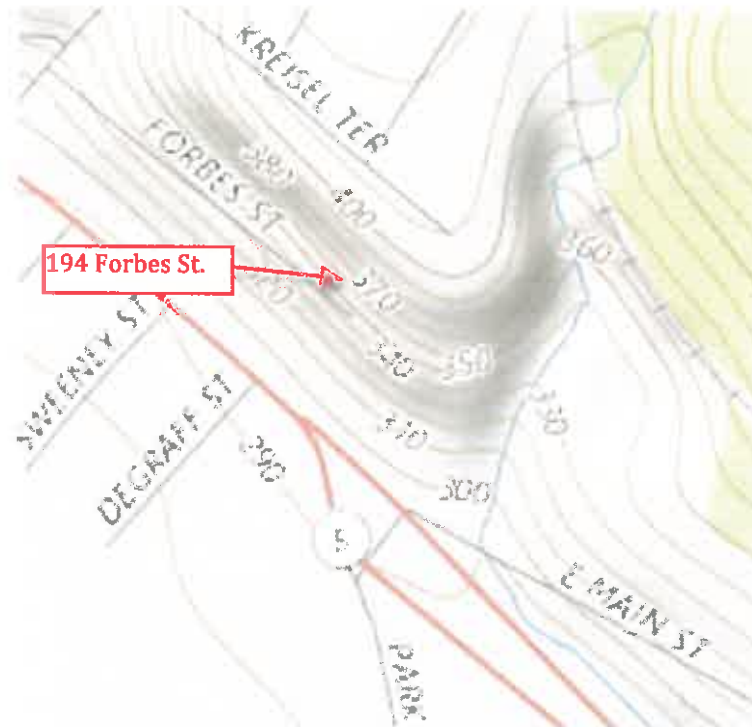
Your home was built in 1910, on a steep, terraced hillside (see topography in photo A1). The home is located approximately 20' above the street (Forbes St.), and is accessible via a wooden staircase. There exists a low terrain wall at the front (south) of your home.

Photo A1:
Topography of property

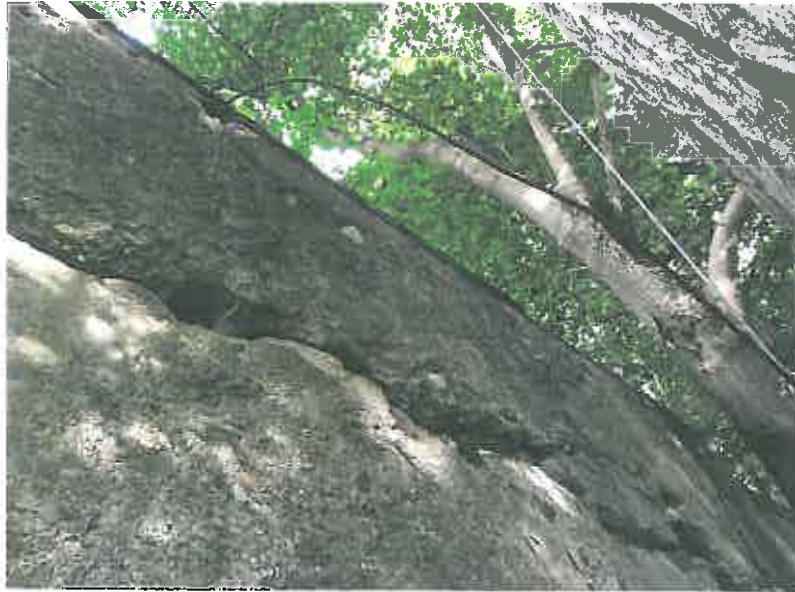
When the western segment(s) of retaining wall collapsed, it failed by overturning. Based on the sequence of events, the build-up of large hydrostatic forces from the waterline break resulted in too high of loads for the wall to resist. The first two adjacent remaining segments of retaining wall has significant cracking along the upper 1/3 of the wall, (see photo A3), and there has been significant movement from its original position. Each wall segment has no visible anchors between the adjacent remaining wall segments since no anchor could be seen at the portion of wall collapse, nor at the junction between wall segments 3 and 4. (see Photo A4).

Photo A3:
Large cracking at concrete wall (Segment 2)

In order for retaining walls to properly support both vertical and lateral forces, they must be able to resist both sliding and overturning. The gravity wall that failed behind your home failed by overturning, and the adjacent wall segments are also at risk for failure, due to the large cracking, and the possibility that similar loading conditions (improper drainage) can lead to further collapse of this wall.

1. A new wall can be built in front of the existing wall, with proper drainage. The existing wall is then left in place. This new retaining wall would be designed to resist the expected vertical and lateral loads.
2. Steel framing and/or concrete buttresses may serve as exterior wall reinforcement. With this wall, since there are significant horizontal cracking, portions of the wall have already shifted, and there is a steep descending slope, this method may prove to be difficult or too-costly to construct.
3. The existing wall is removed, and a new retaining wall is installed. This method may be difficult to do, since there is a home close to the top of the

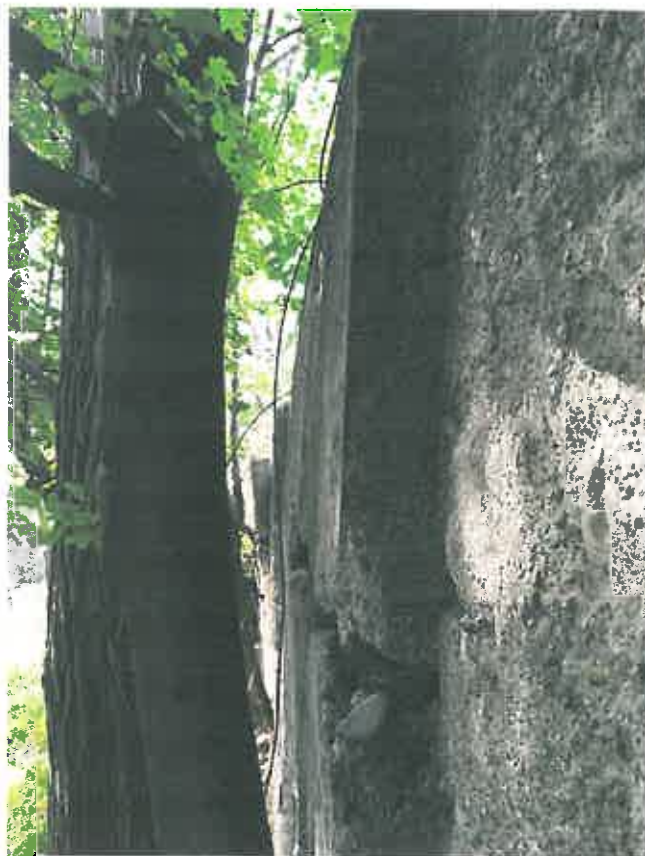
- Photo A4:**
- Segment 3 wall: large cracking and movement
 - Segment 4 wall: no large cracks or movement
 - Note the setting rebar left in-place at the top of wall

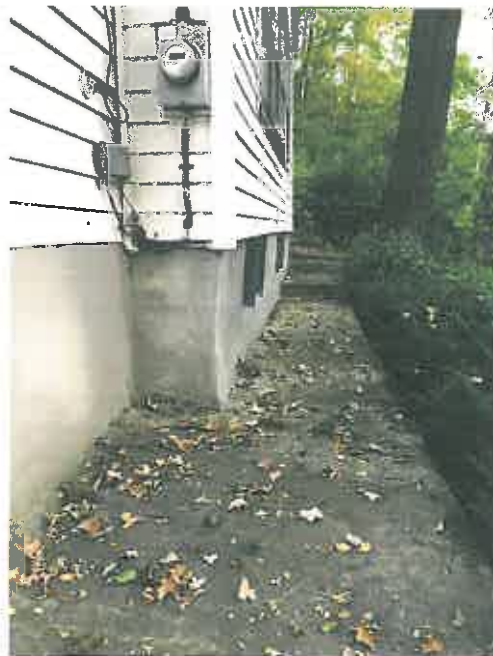
The overall condition of your home is in fairly good shape- the roof & floor joists do not show any signs of decay/damage, and it was determined that the retaining wall collapse did not create any visible damage to the home. The only portion of your home that does require remediation, are settlement issues from residing on a steep terrain. There are signs of settling and/or shifting over the years, based on past concrete repair work of the foundation walls, as well as floors out-of-plumb (See photo A5). The descending slope from your home should not be closer to the foundation than 1/3 of the total hill height (from street to foundation). Your home is located approximately 20' above the street level, so the slope should be located at least 7' from the edge of the footings. Or, a retaining wall should be built to support both the vertical and lateral loads from the home.

Photo A6:
Front steep descending grade, close to home

1. New, taller, terraced walls should be installed to the south of the home to provide better support for the home's loads. These walls should extend the soil more than 7' from the edge of the existing footings.
2. The main house can be brought back to plumb by slowly raising the home, for the installation of additional sill plates and/or shims.
